Optimizing Sonar Performance by Managing Acoustics

Marisa Yearata and Timothy Gates

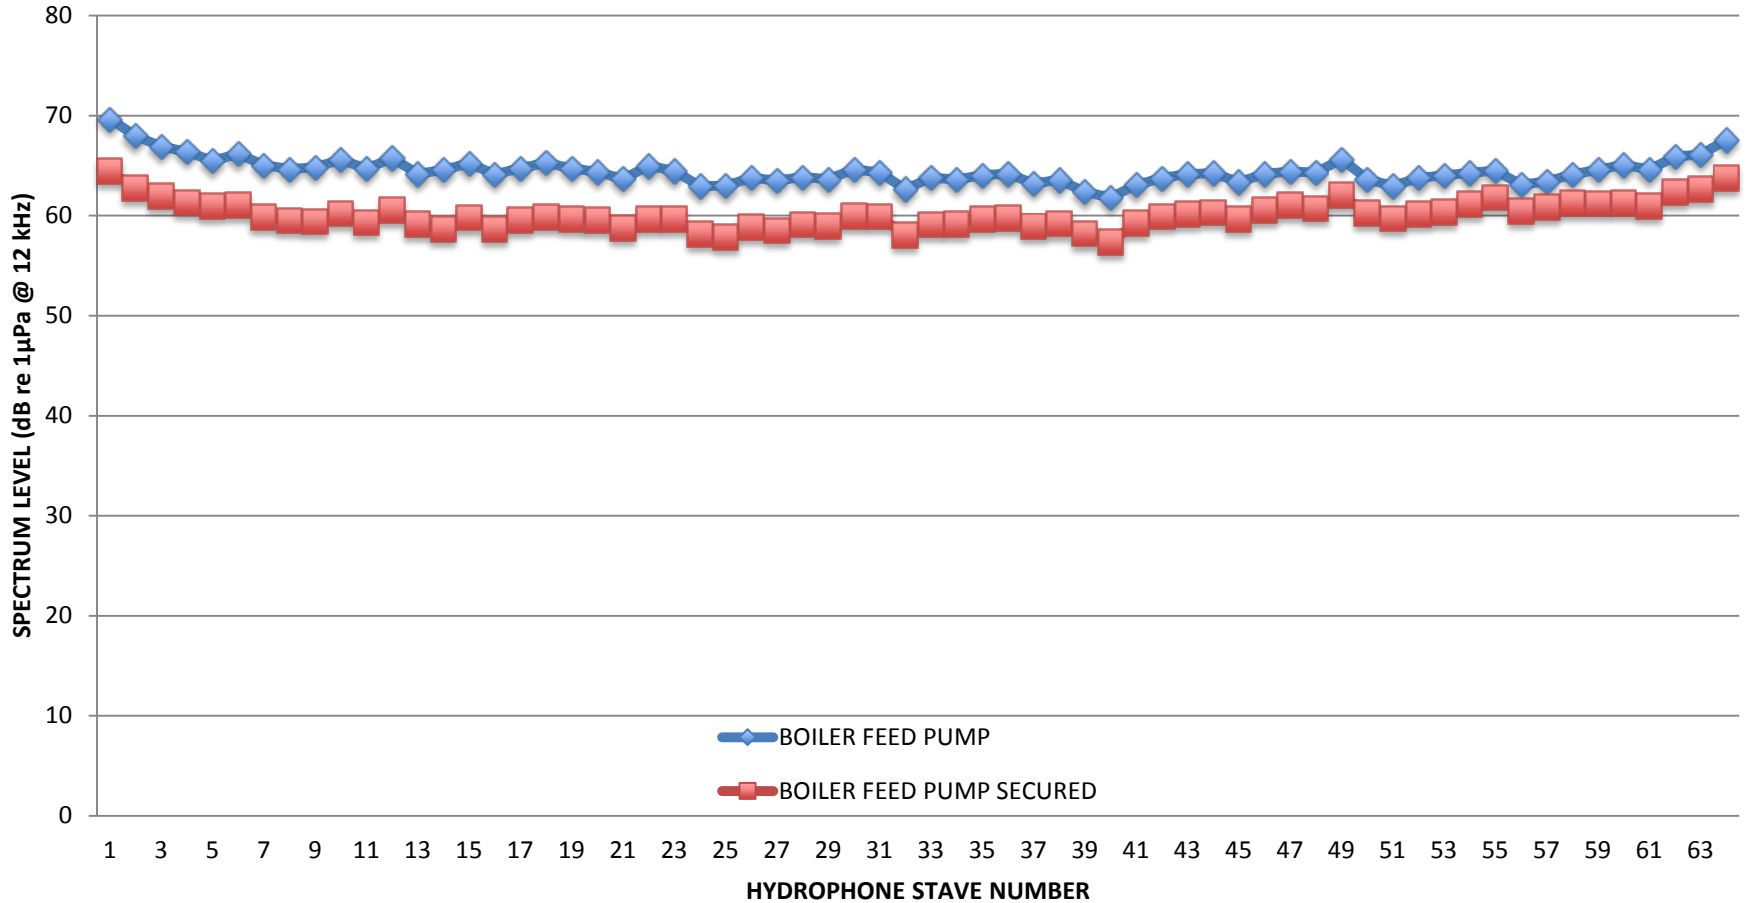
**USCGC HEALY (WAGB-20)
BOILER FEED PUMP ON VS OFF
EM122 RX NOISE LEVEL
17 AUGUST 2014**

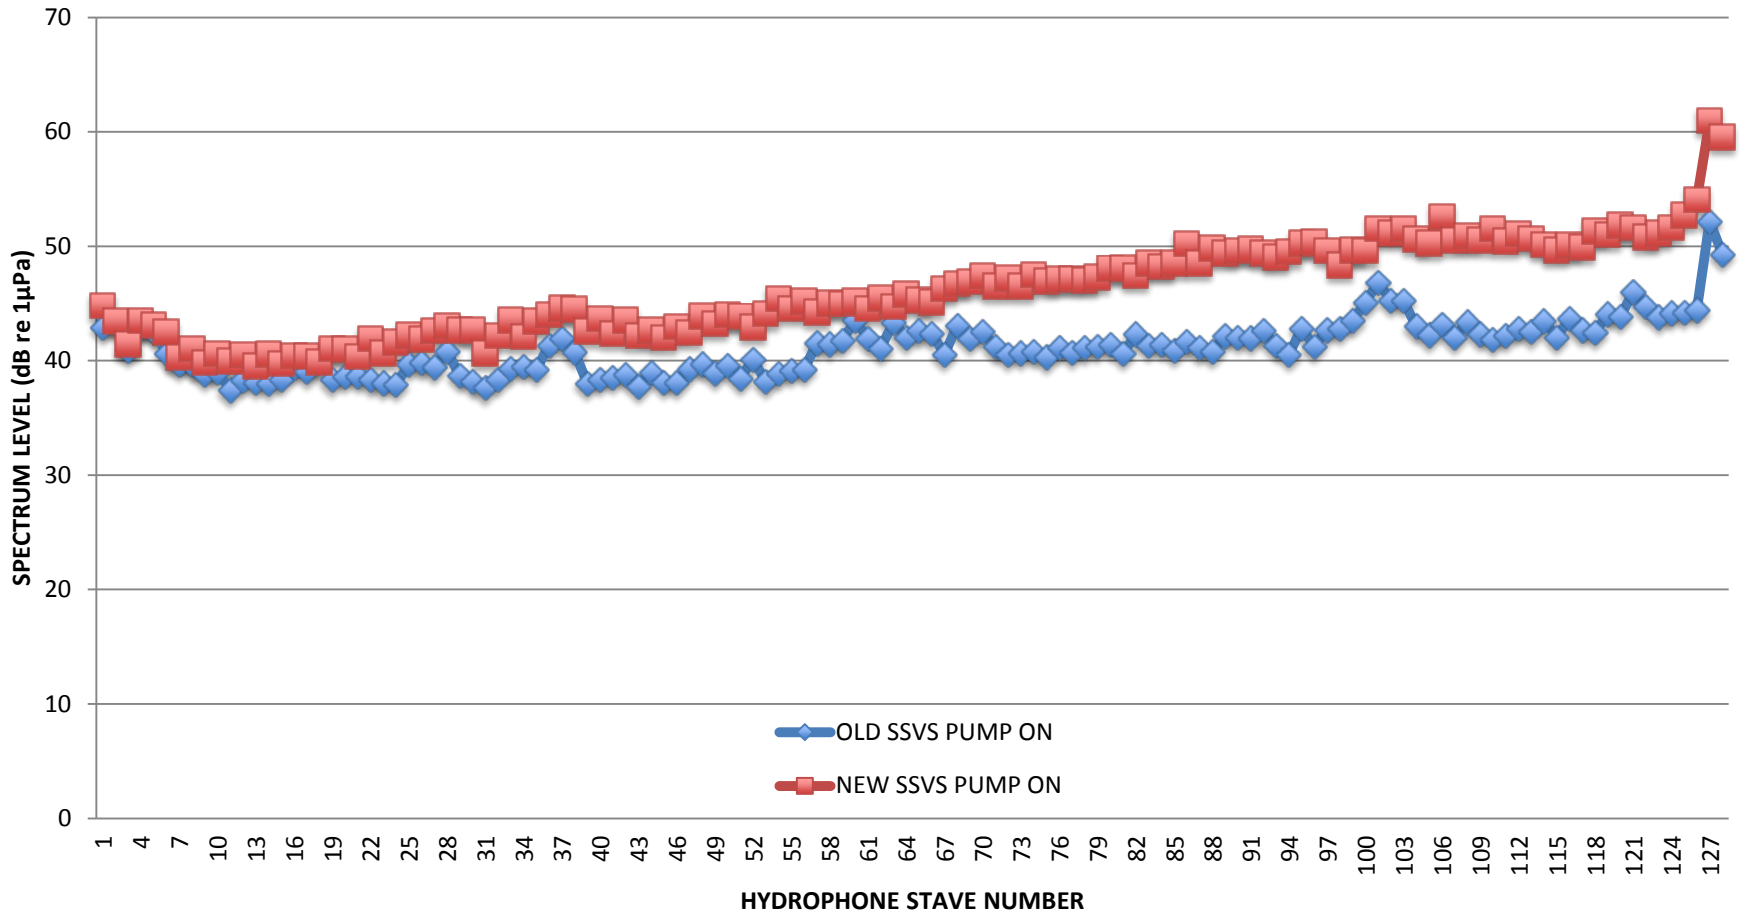
**E/V NAUTILUS
EM 302 RX NOISE LEVEL
OLD VS NEW SSVS PUMP COMPARISON
5 MAY 2014**

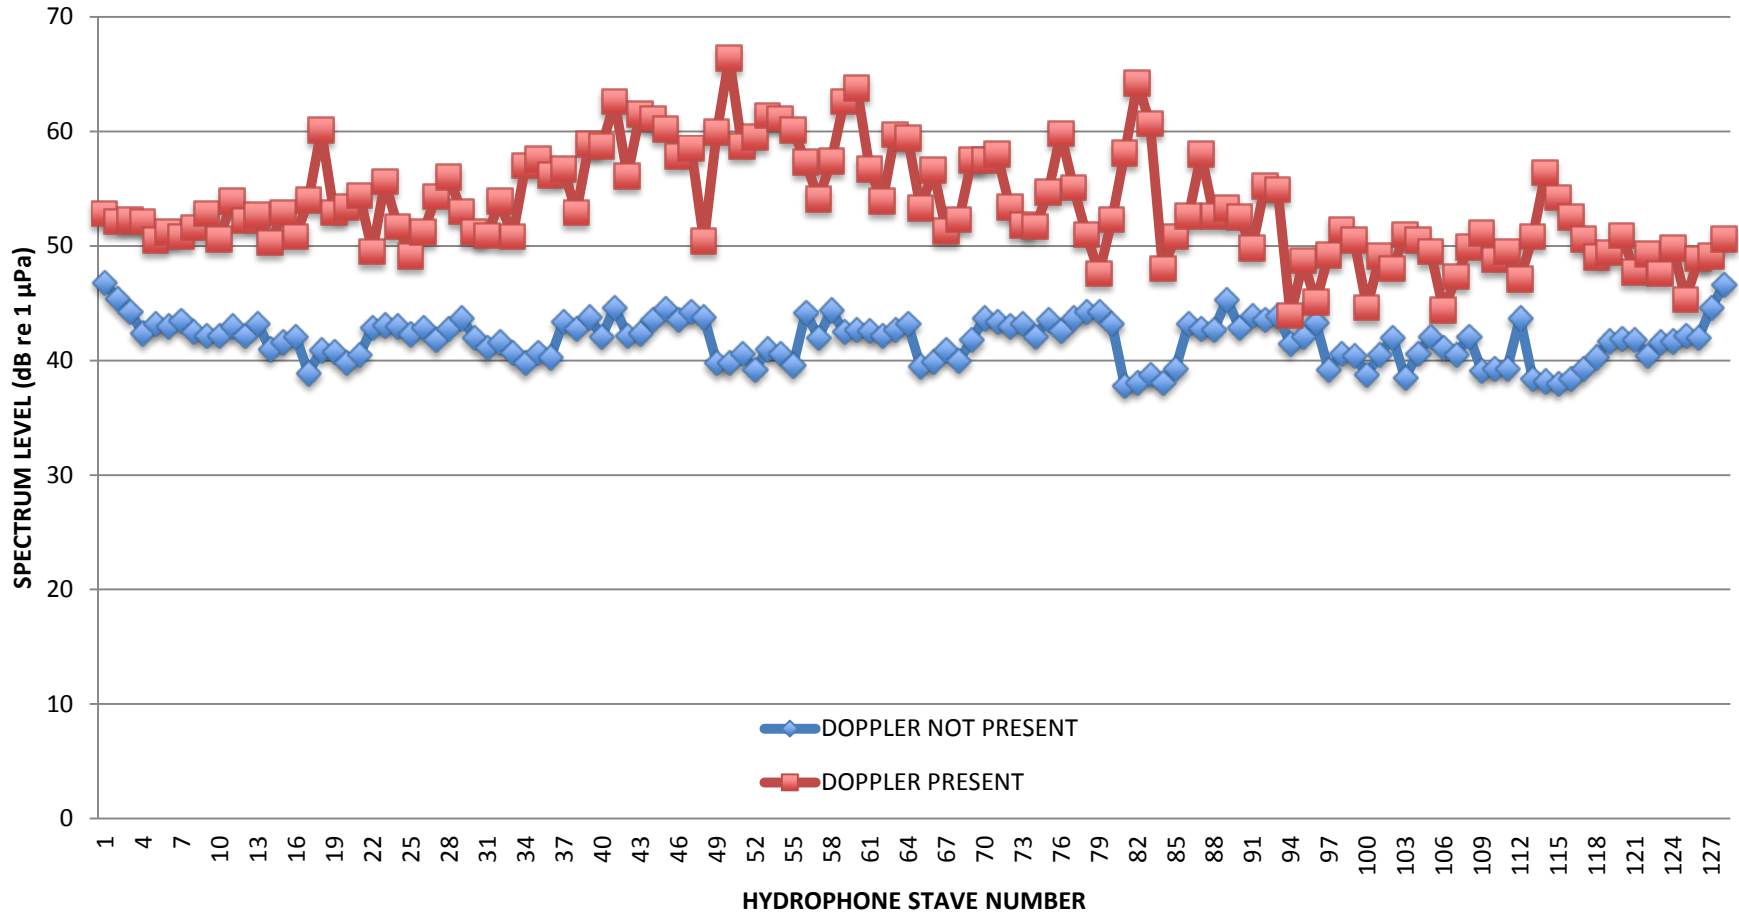
NOAA Ship *OKEANOS EXPLORER* (R-337)
DOPPLER SPEED LOG IMPACT - 8 KNOTS
EM 302 RX NOISE LEVEL
7 FEBRUARY 2014

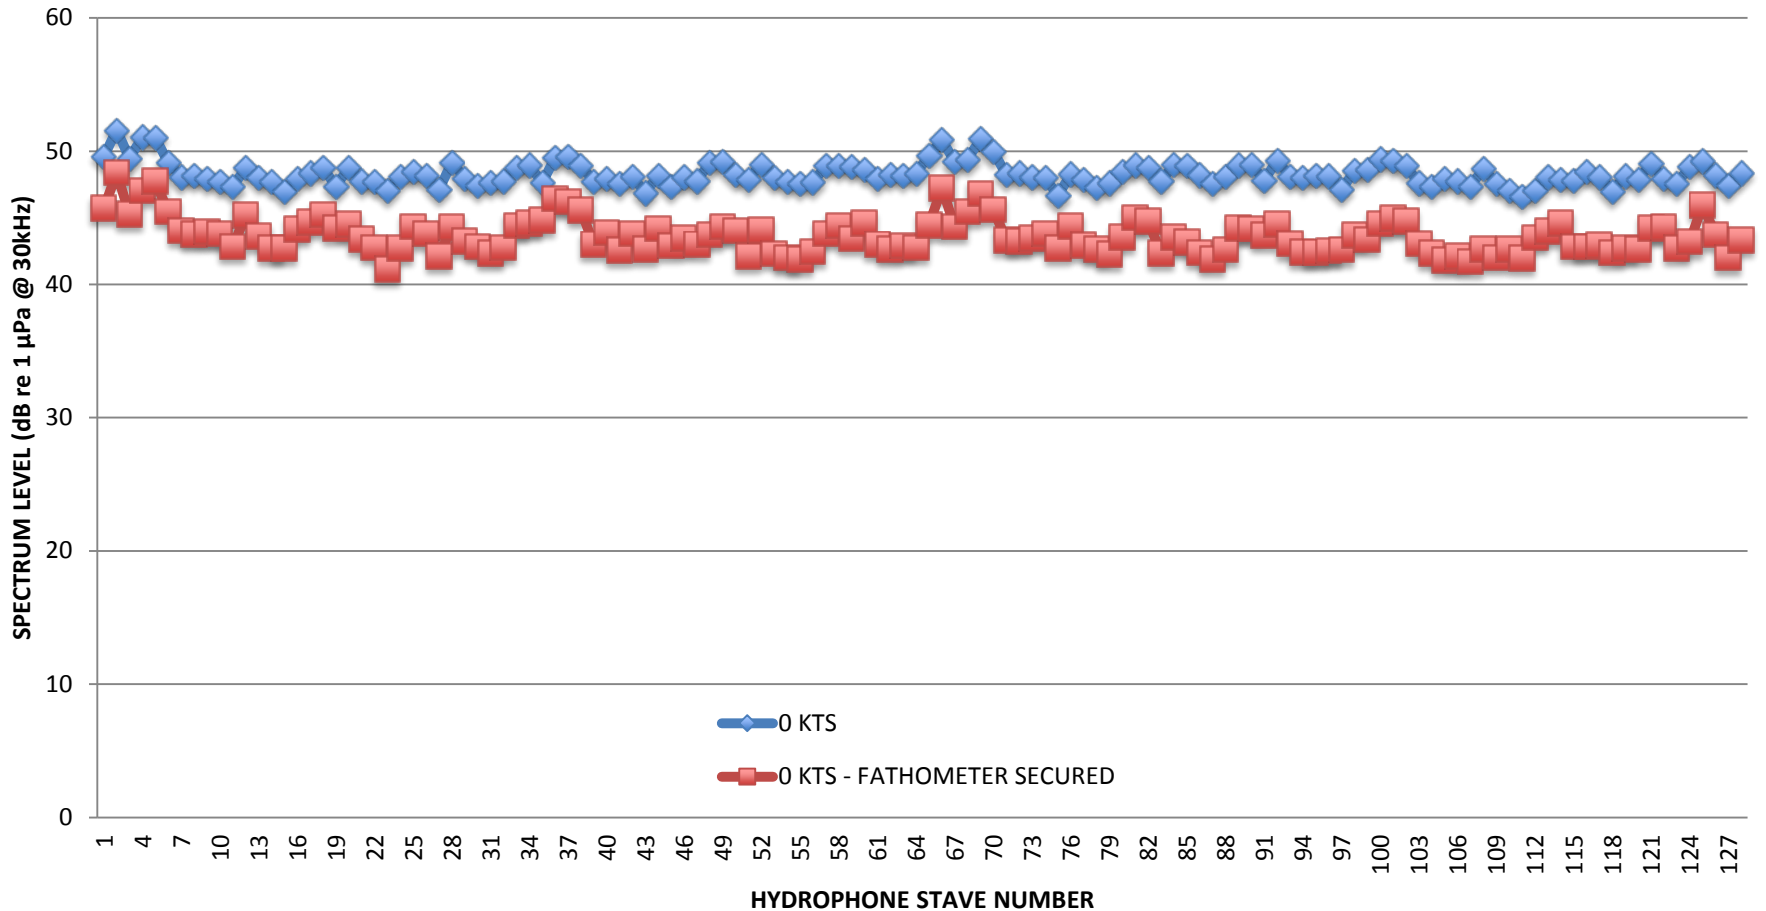
**R/V SIKULIAQ
EM302 RX NOISE LEVEL
0 KTS - FATHOMETER ON VS SECURED
16 JULY 2014**

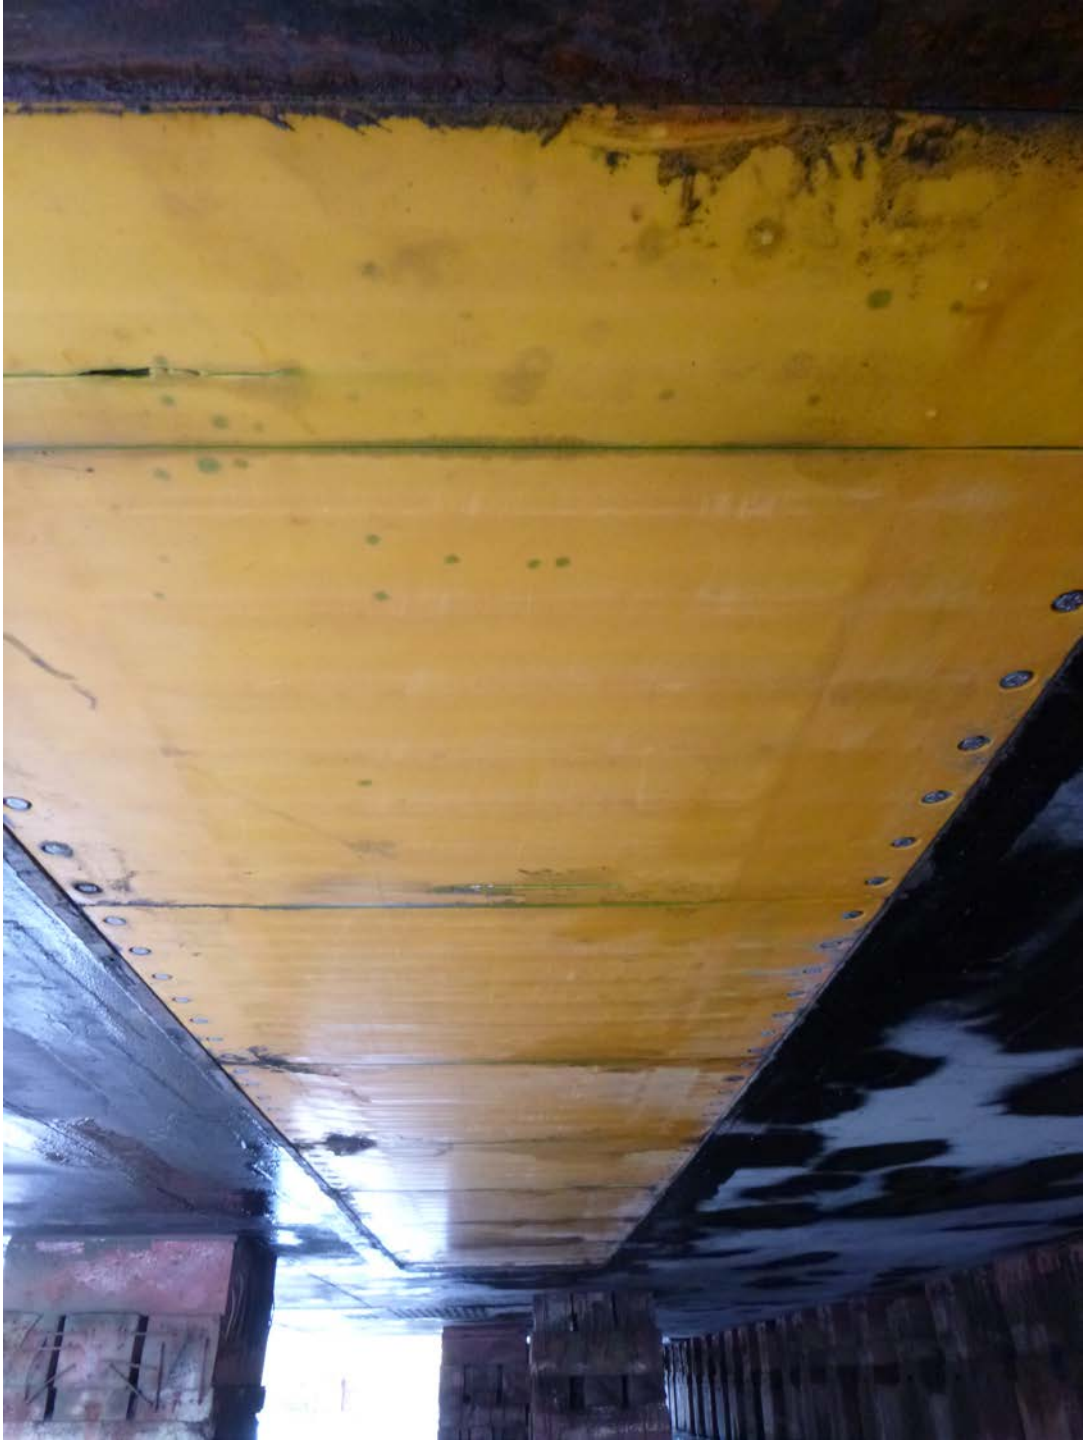
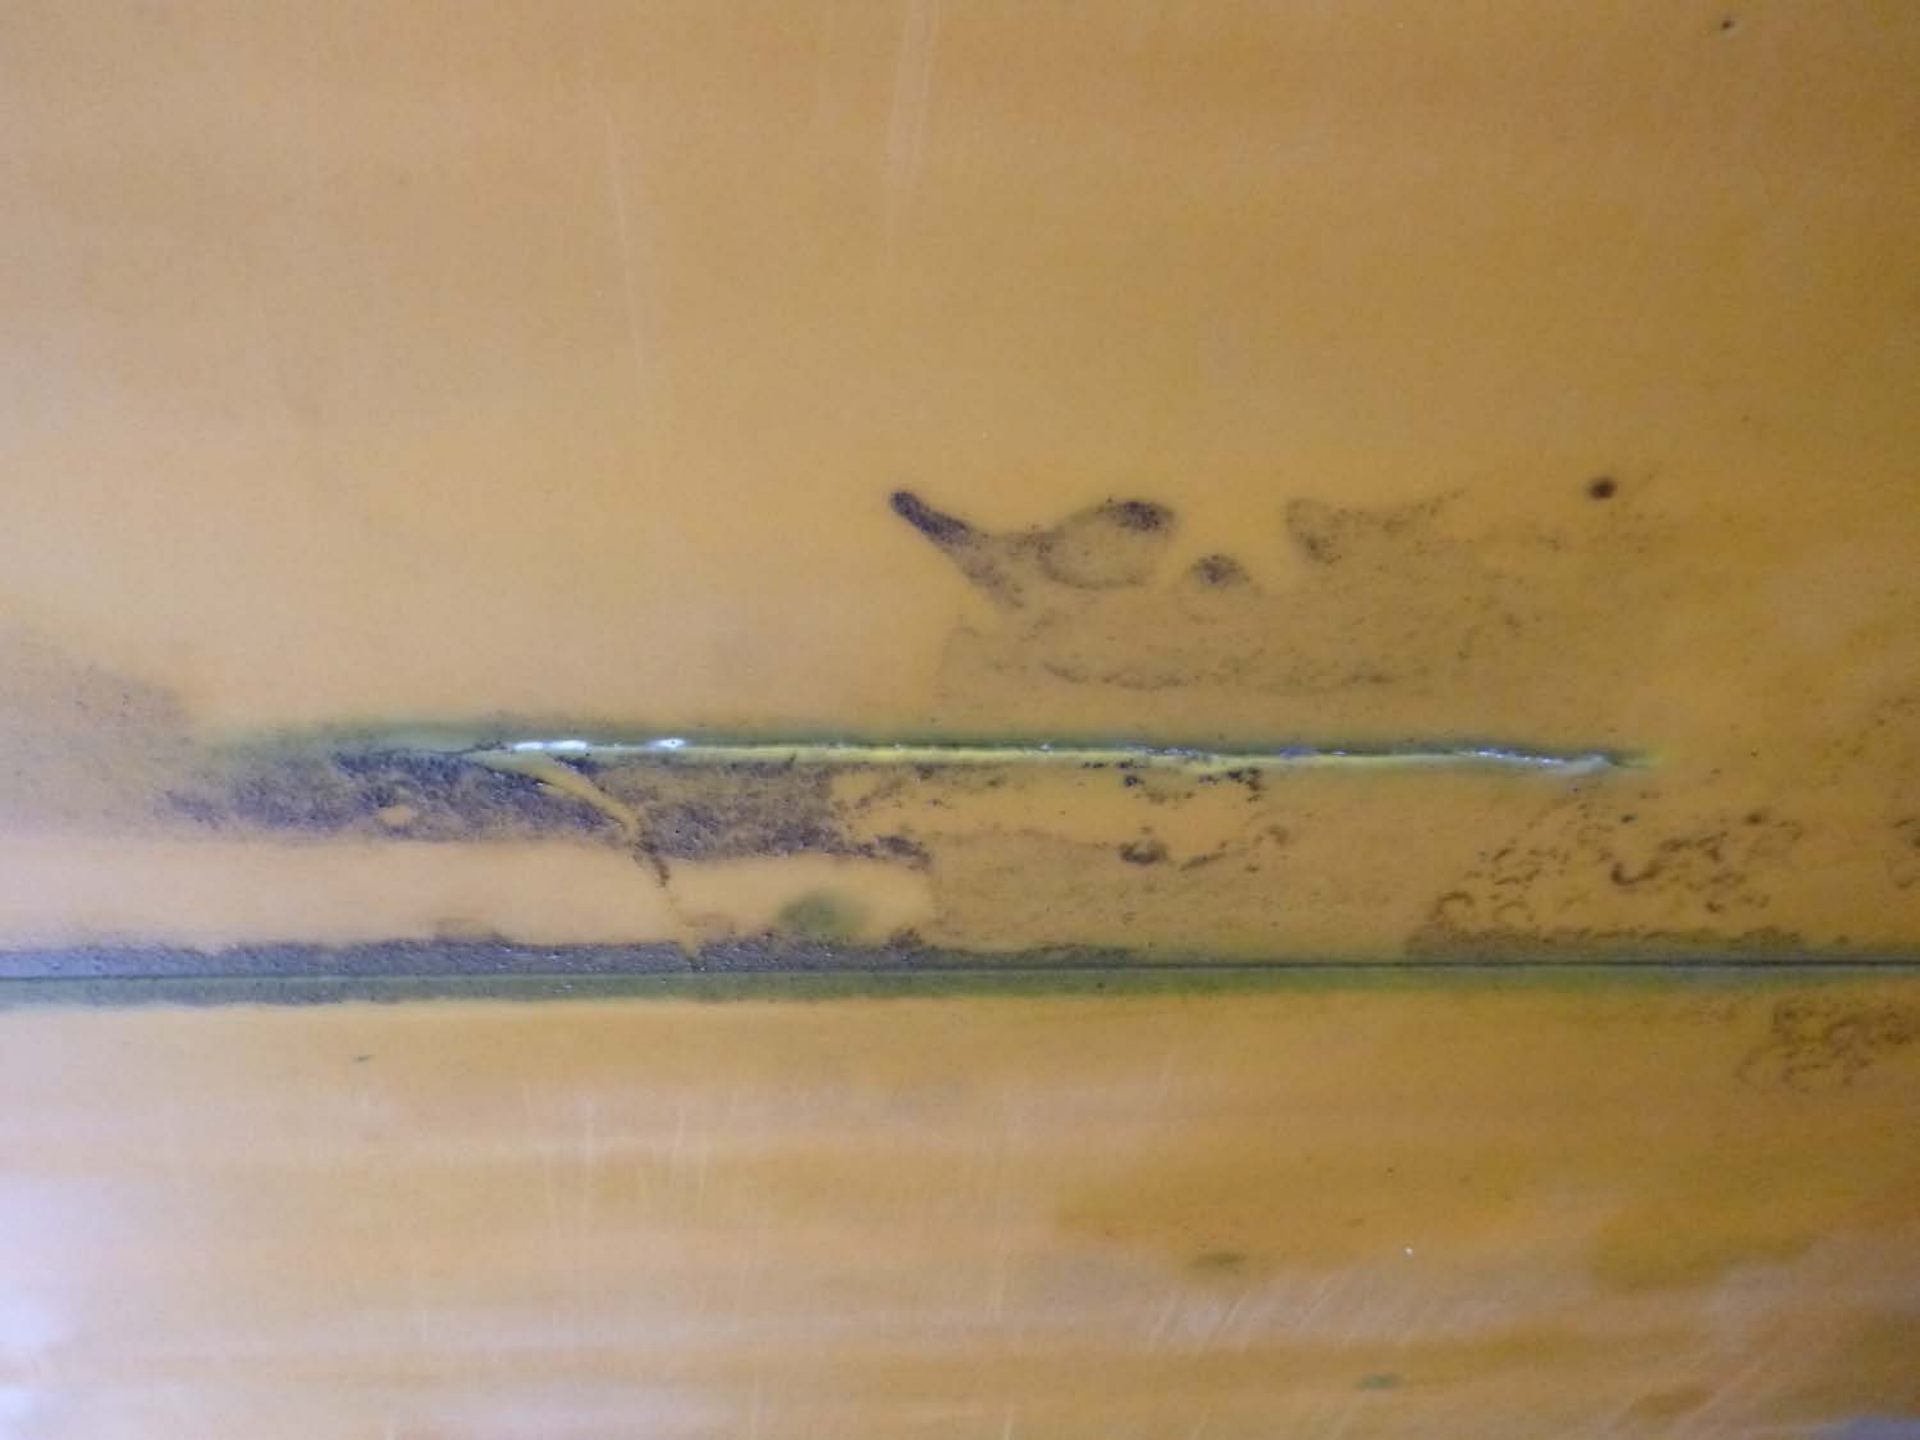
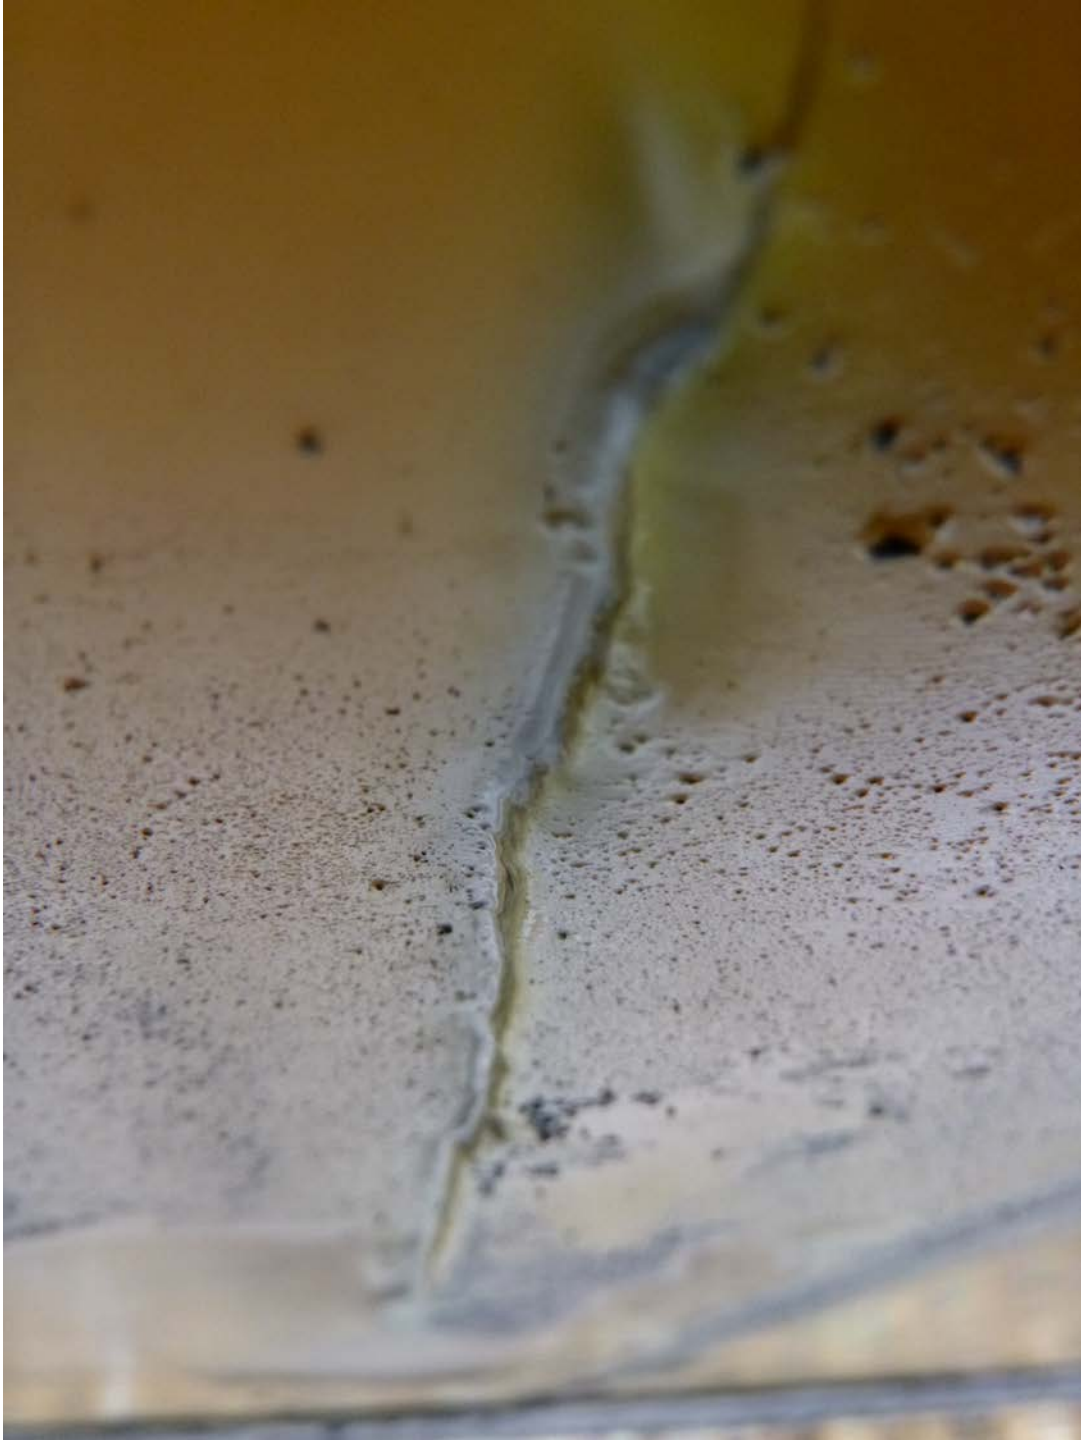
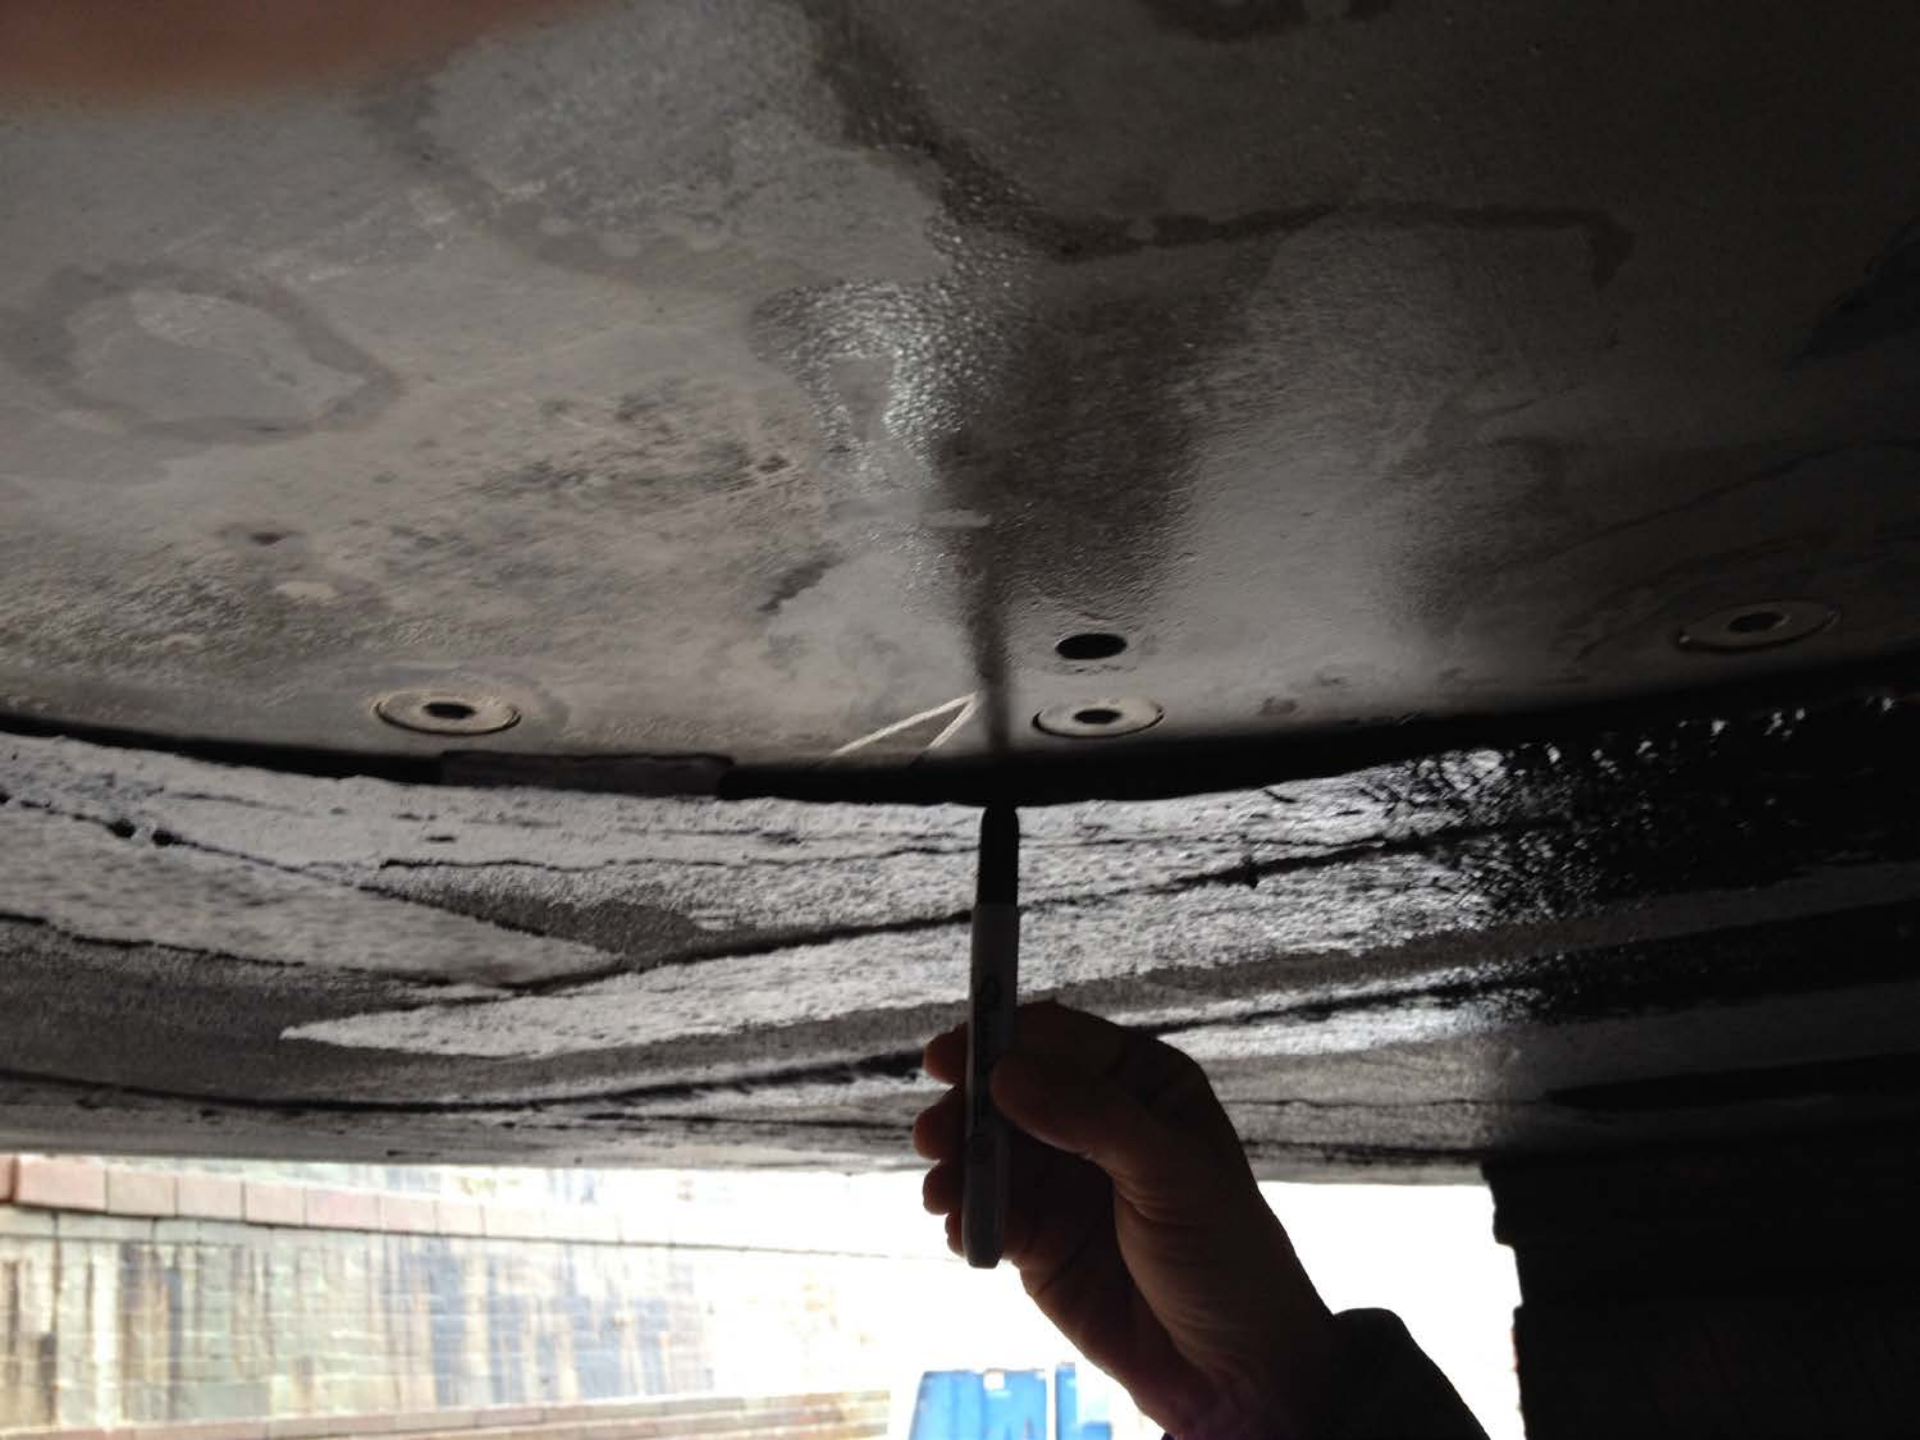
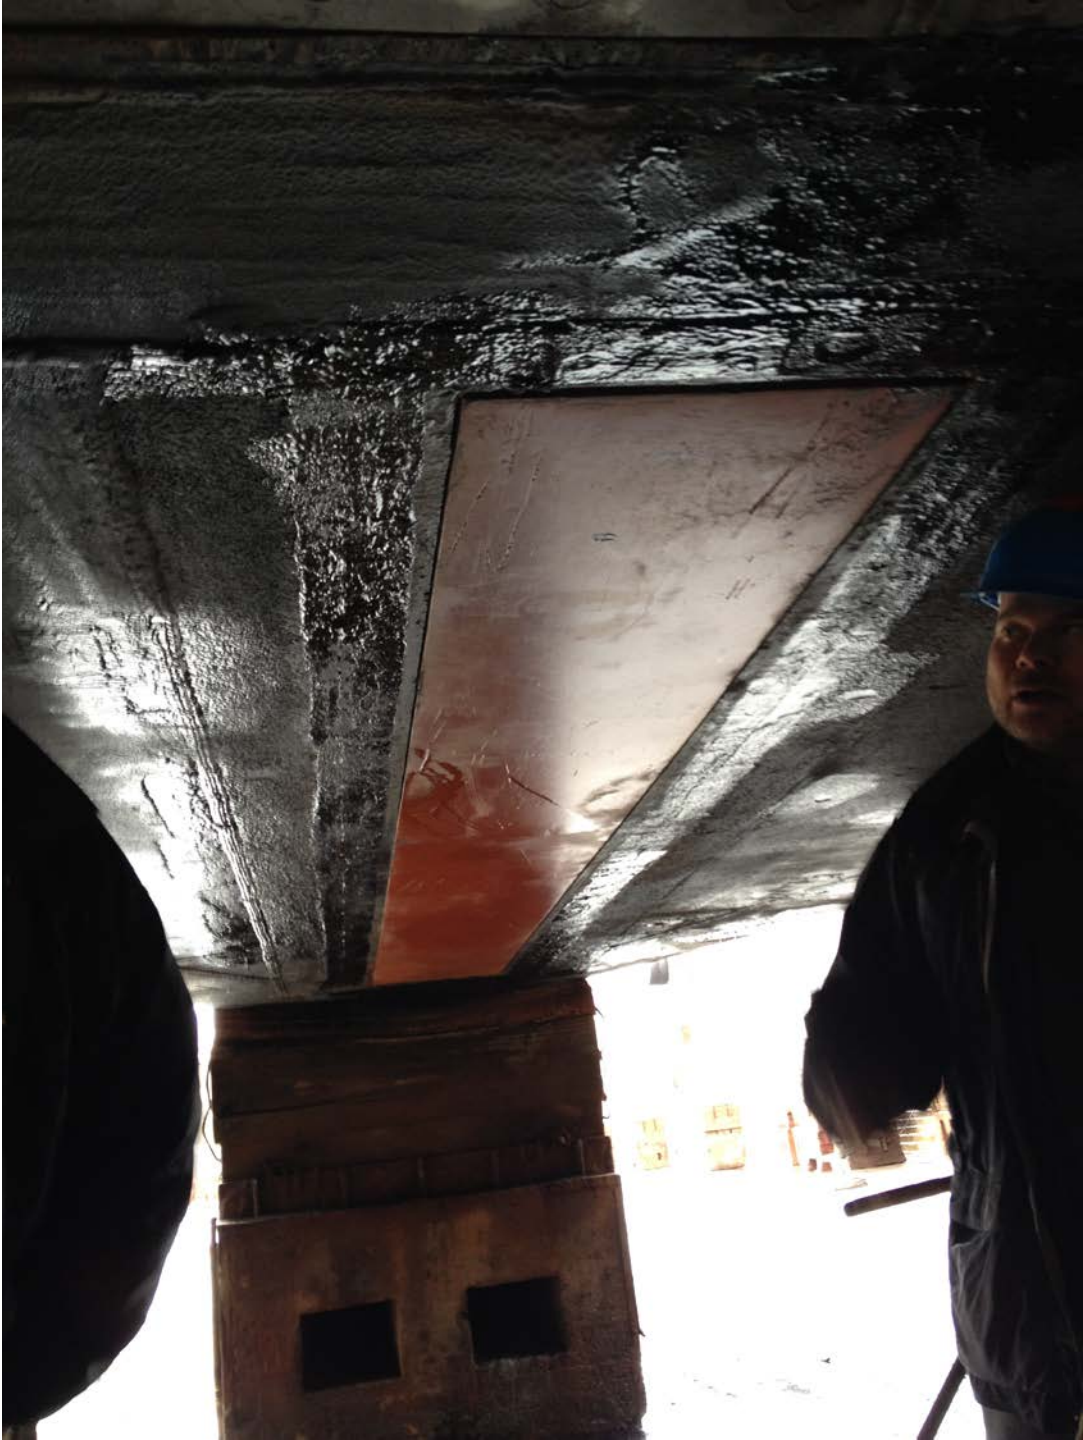
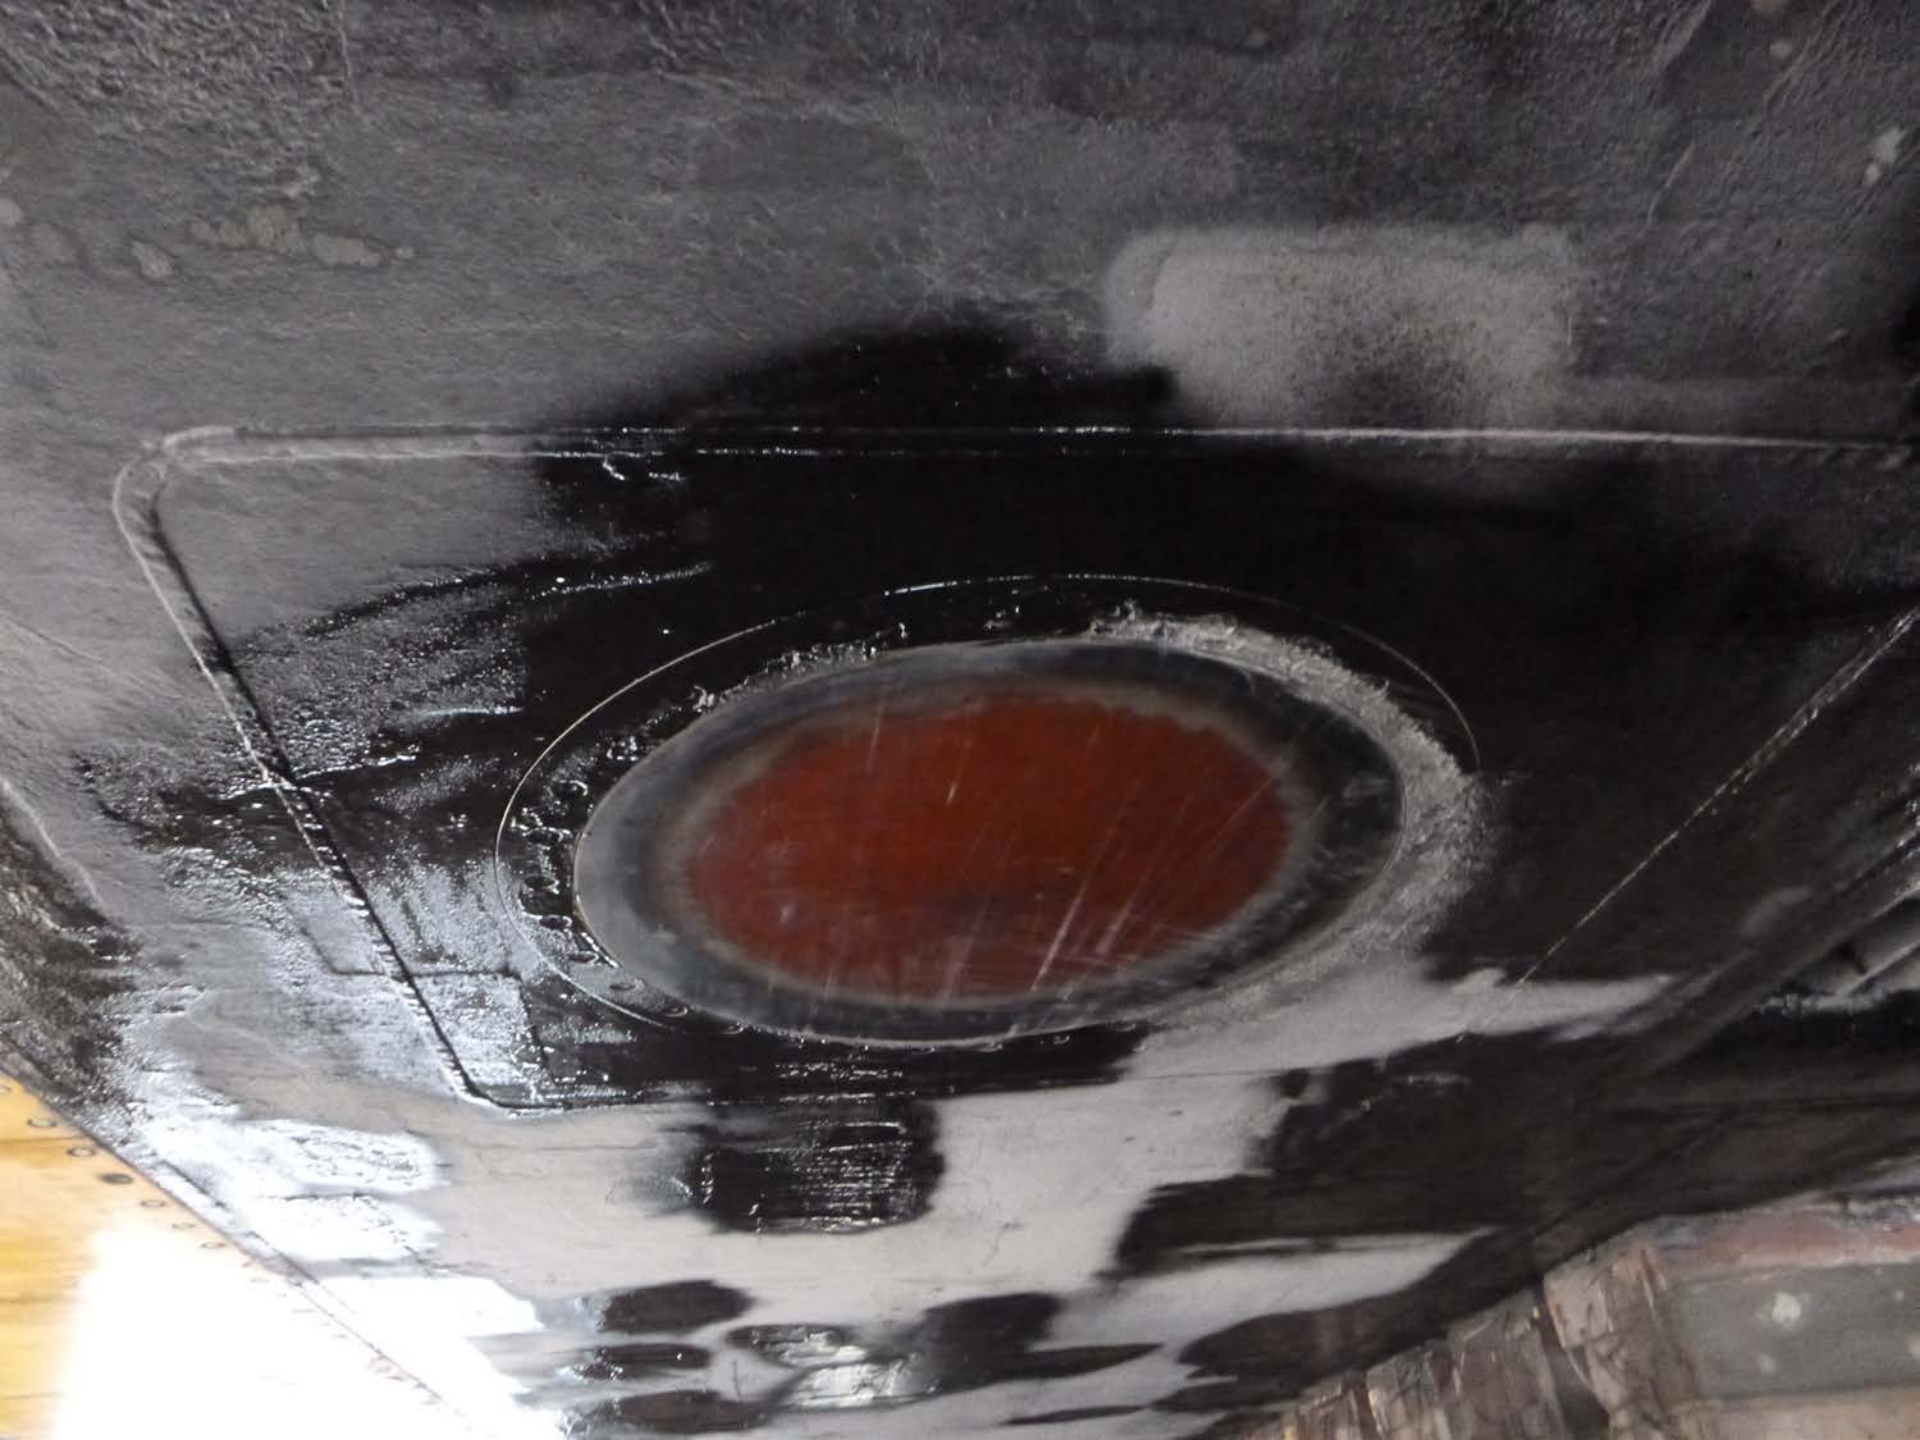
- Drydock inspection revealed extremely poor conditions near sonar transducers
- Gaps were noted between transducer faces and ships hull
- Paint conditions were terrible
- Sonar acoustic windows possessed major cracks
- These conditions will significantly degrade hydrodynamic flow noise levels

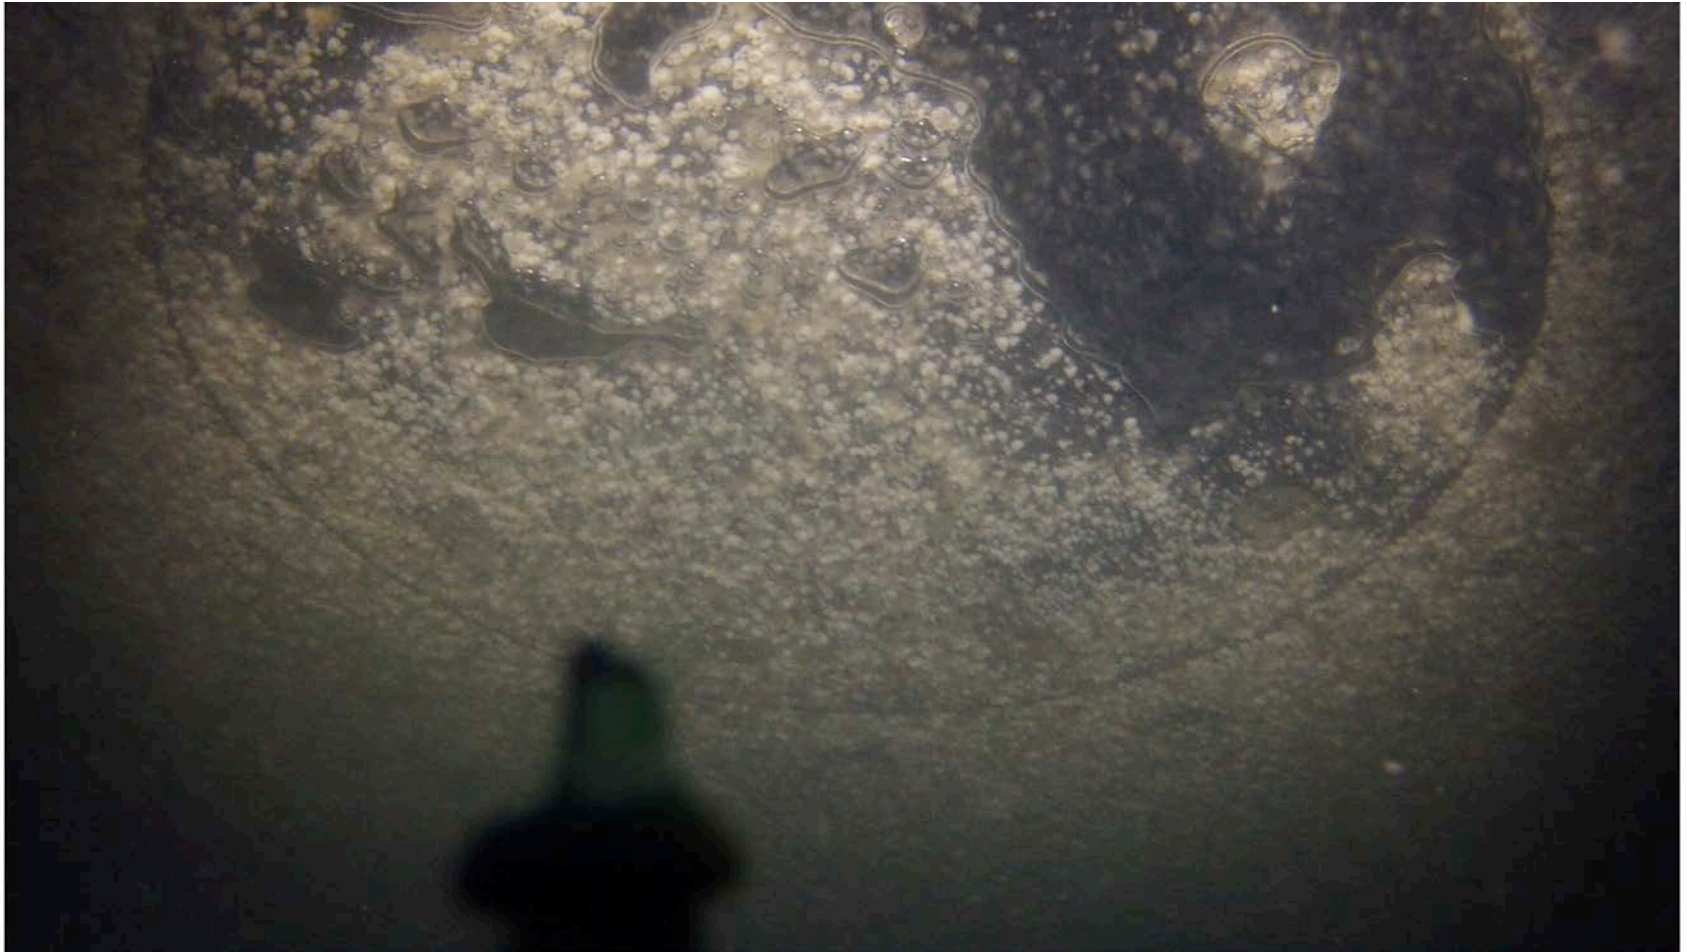
R/V SIKULIAQ - ADCP

- SIKULIAQ was significantly fouled during baseline acoustic testing
- Sonar levels were completely controlled by hydrodynamic flow noise at vessel of 3 knots and above

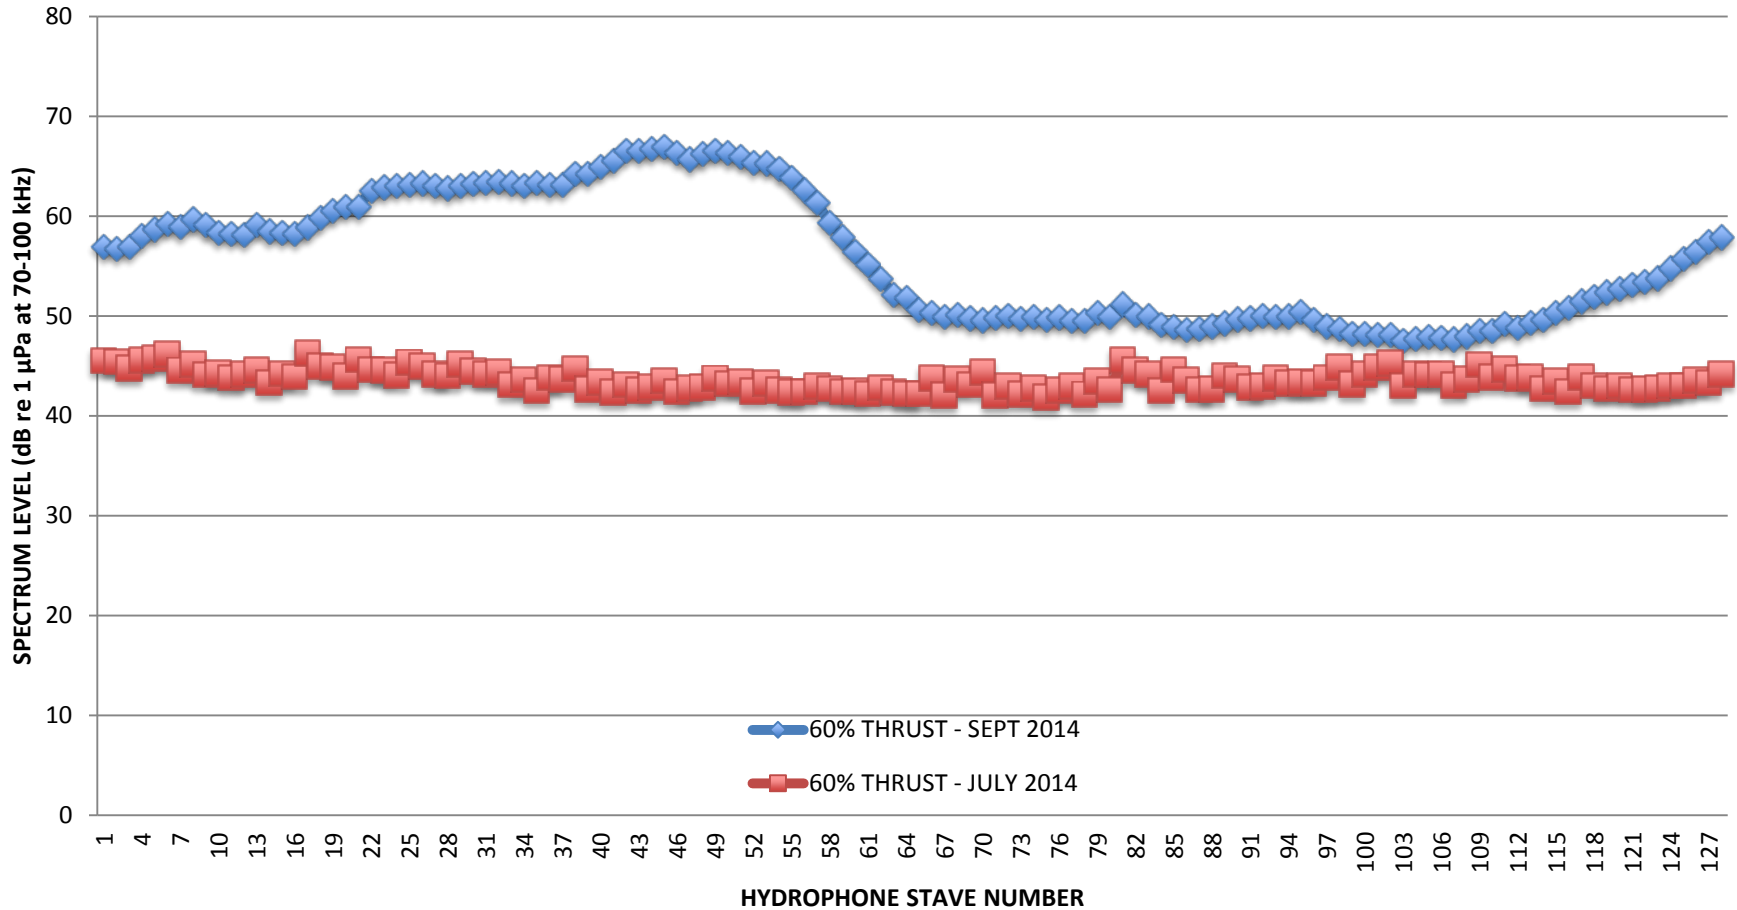
**R/V SIKULIAQ
EM 710 RX NOISE LEVEL
60% THRUST - JULY VERSUS SEPTEMBER 2014
15 SEPTEMBER 2014**
