Optimizing Sonar Performance by Managing Acoustics

Marisa Yearata and Timothy Gates

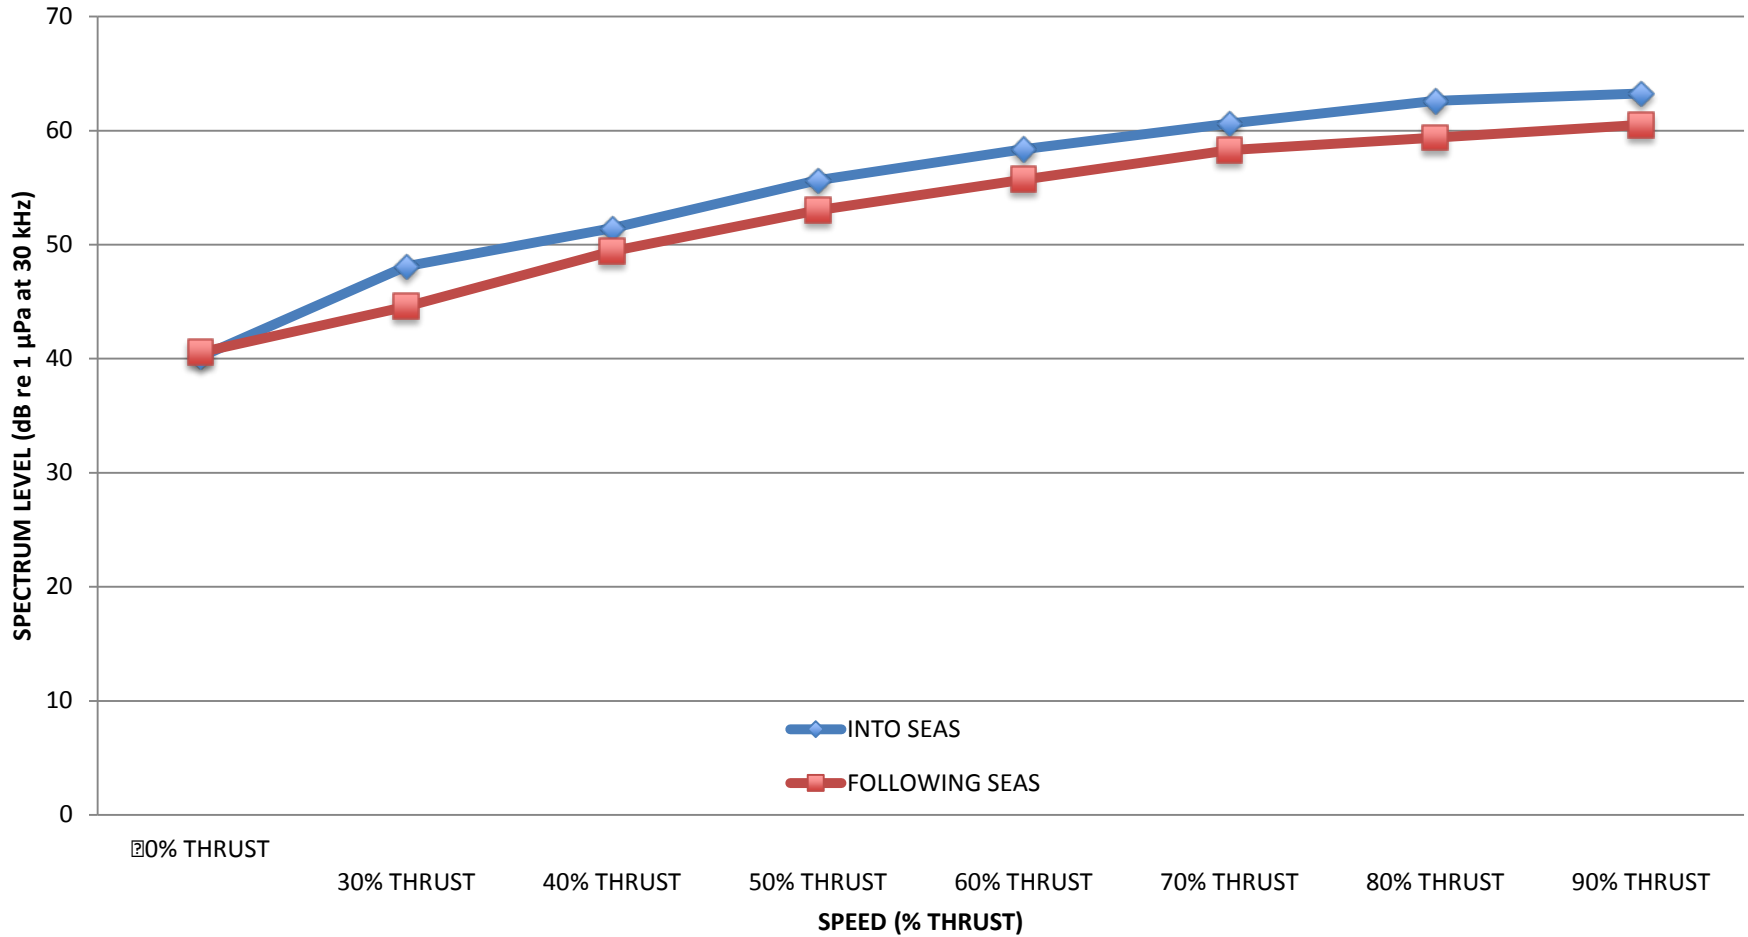
**R/V SIKULIAQ
EM 302 RX NOISE LEVEL
SPEED VS 30 kHz LEVEL - INTO VS FOLLOWING SEAS
15 SEPTEMBER 2014**

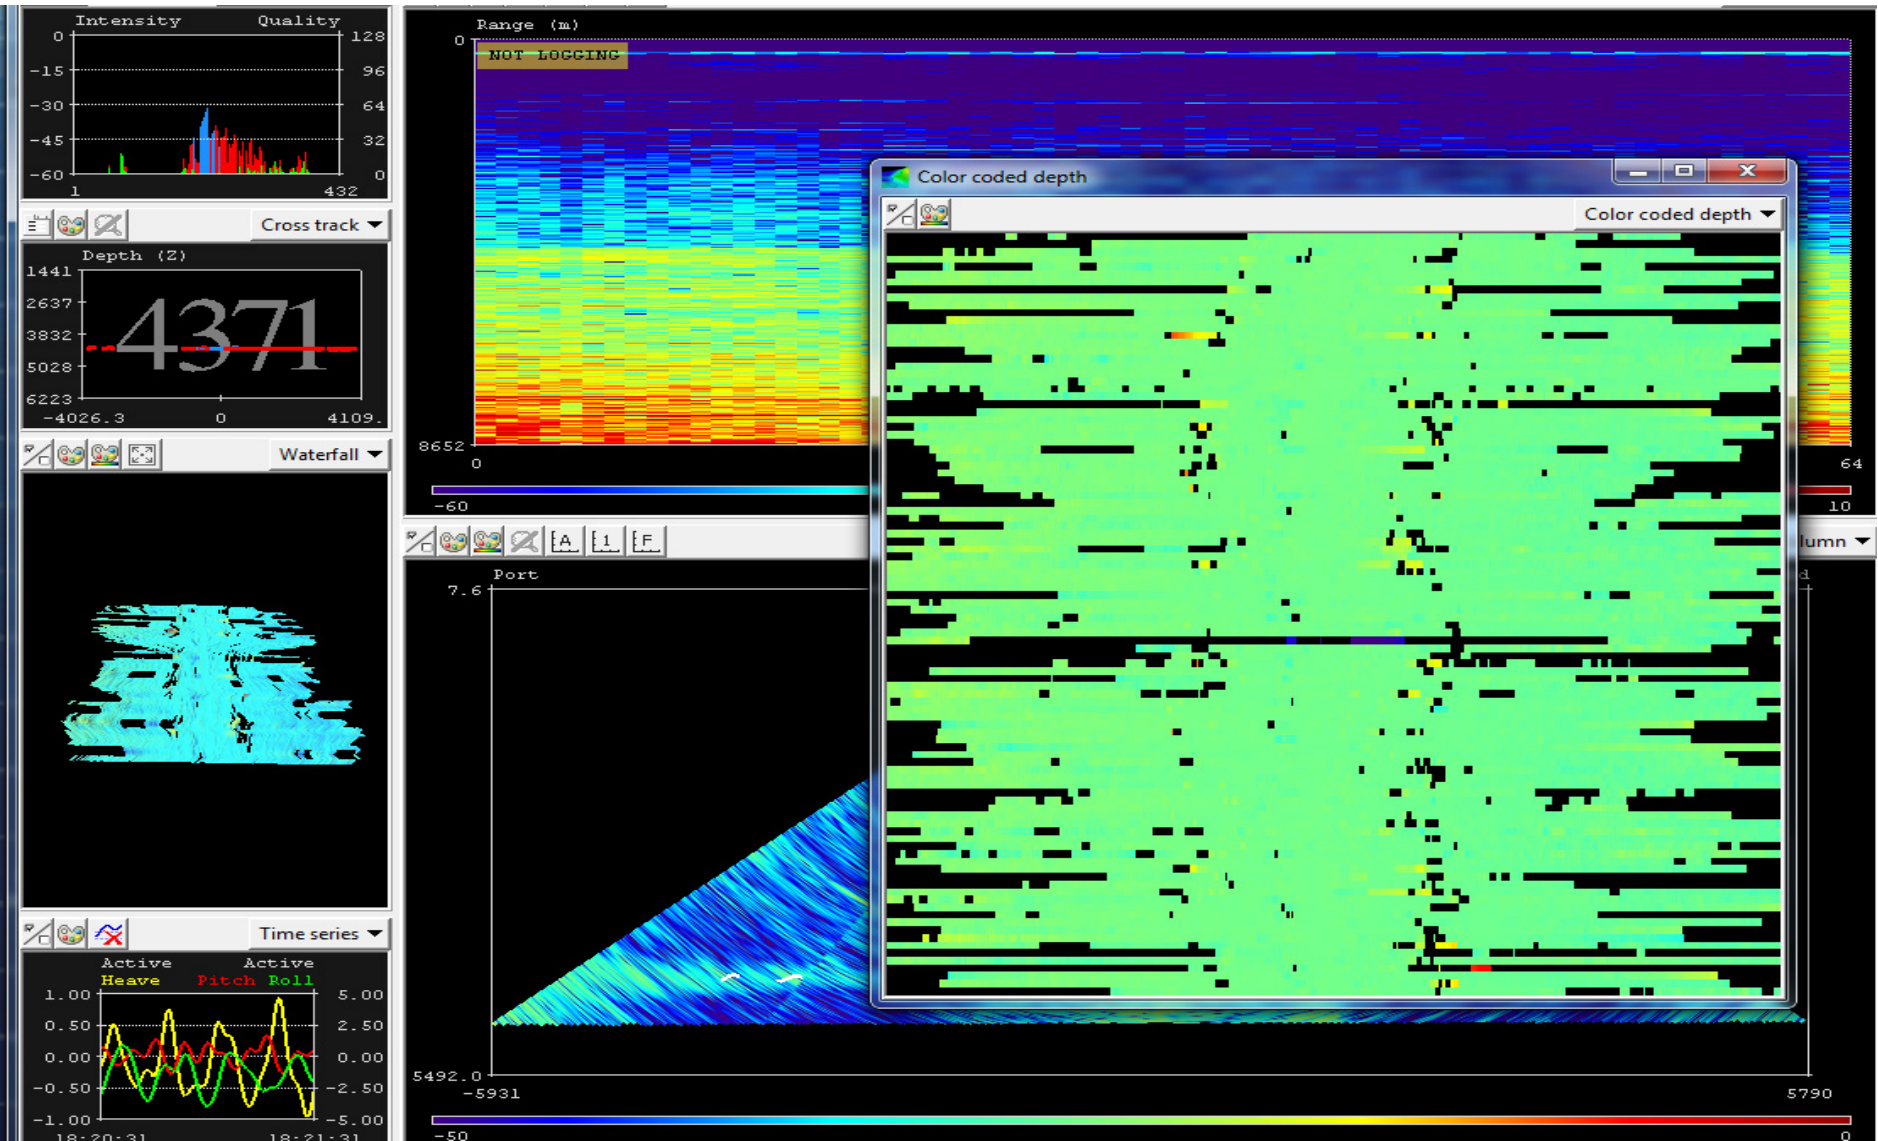
PALMER BUBBLE IMPACT

- Bubble sweepdown is created when air from the bow region is sucked under the ships hull
- If it gets to the sonar transducer region it can severely degrade sonar performance

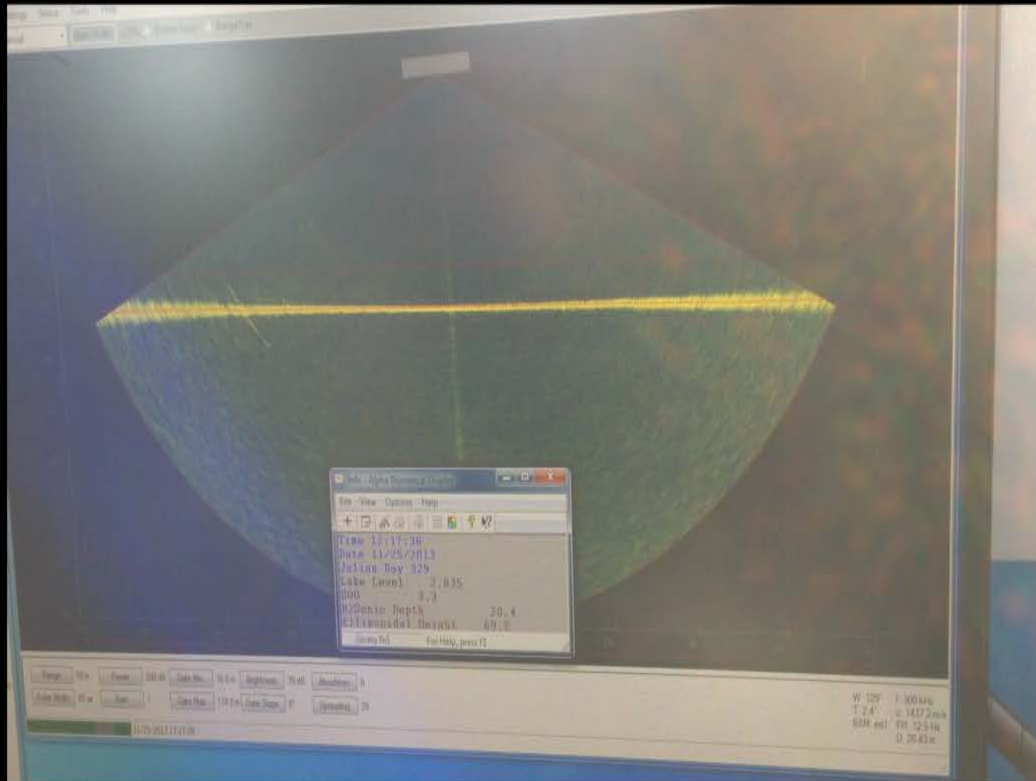
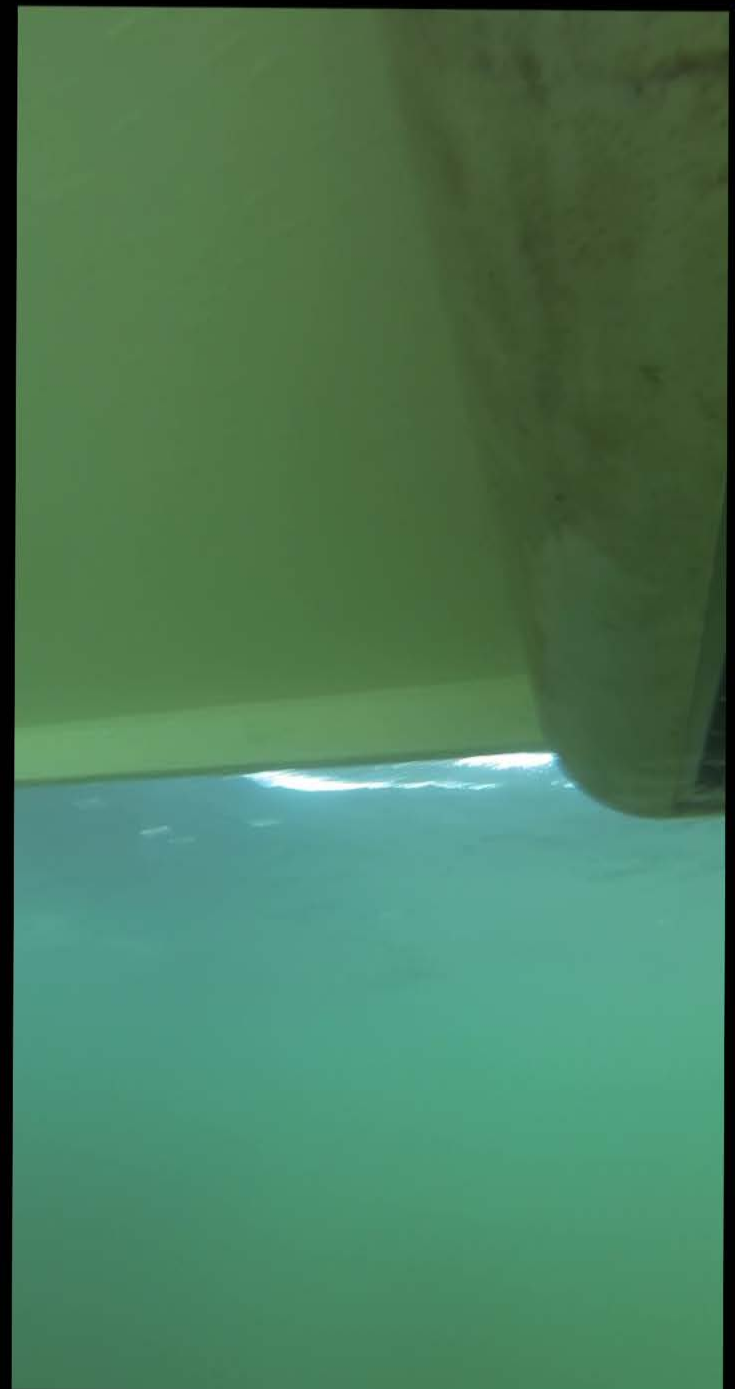
- At any underway speed, random transients were degrading sonar performance
- Problem was more prevalent with any port turn
- Underwater photography was collected with a pole mounted GoPro
- Sonar data dropouts were completely correlated with bubbles impacting sonar transducer face

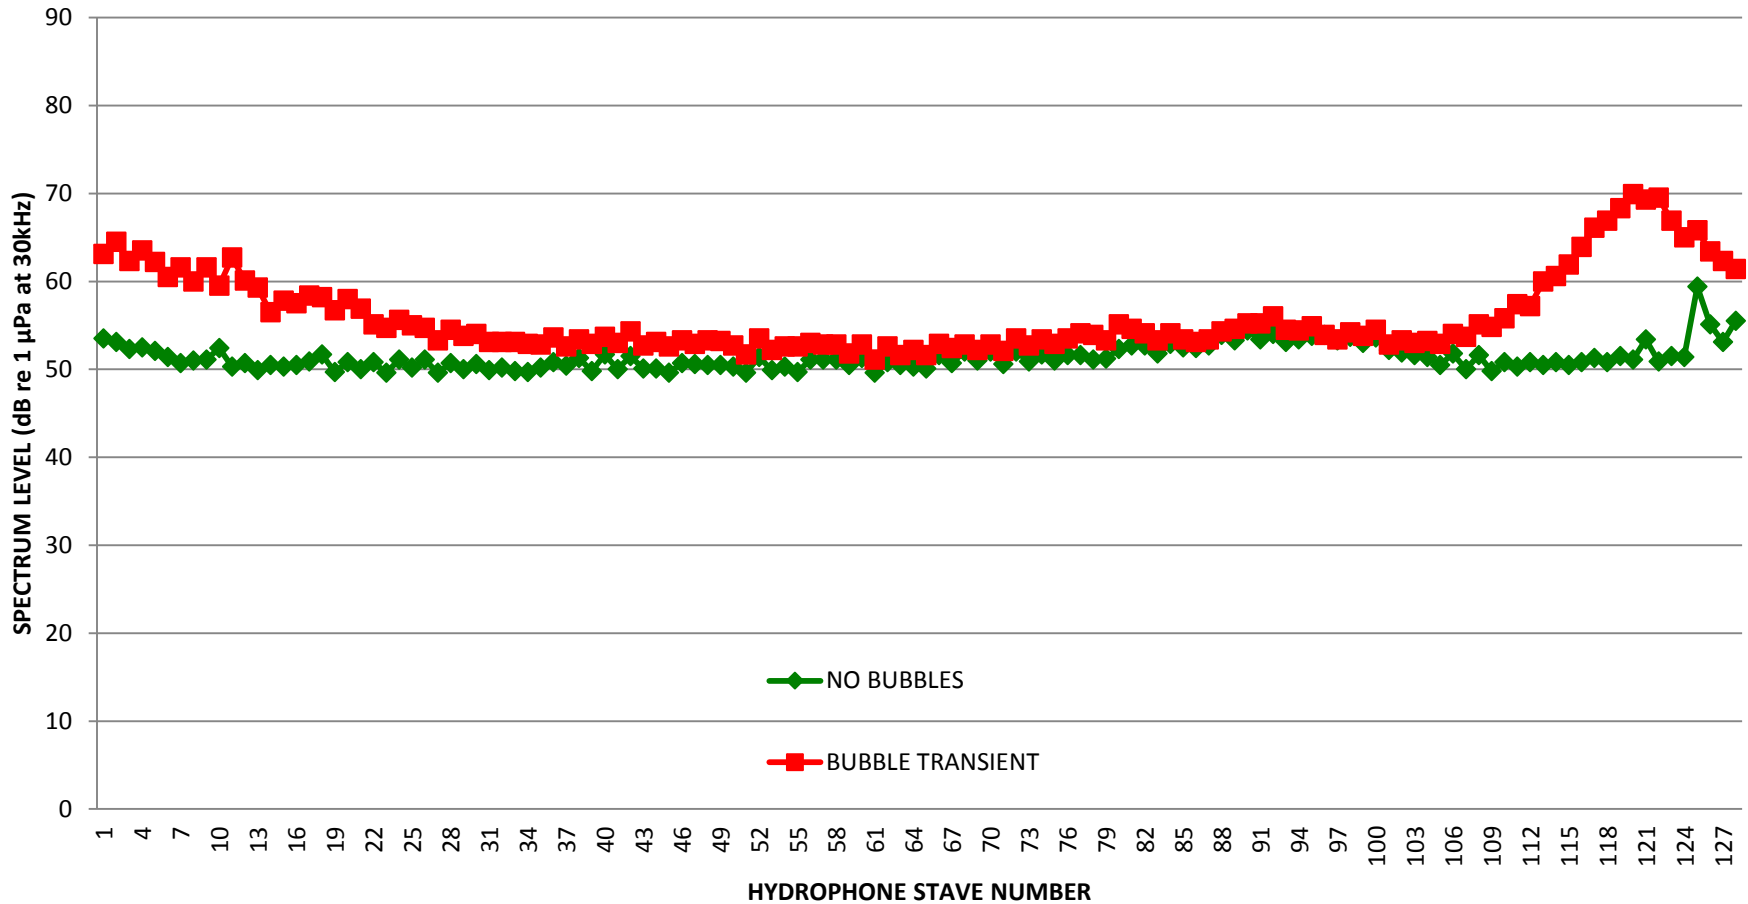
**R/V SIKULIAQ
EM 302 RX NOISE LEVEL
7.5 KTS - 60% THRUST - INTO SEAS
12 SEPTEMBER 2014**

- SIKULIAQ has a lot of bubbles
- SIKULIAQ has an icebreaker hull (notorious for bubbles)
- Bubbles were present at all headings

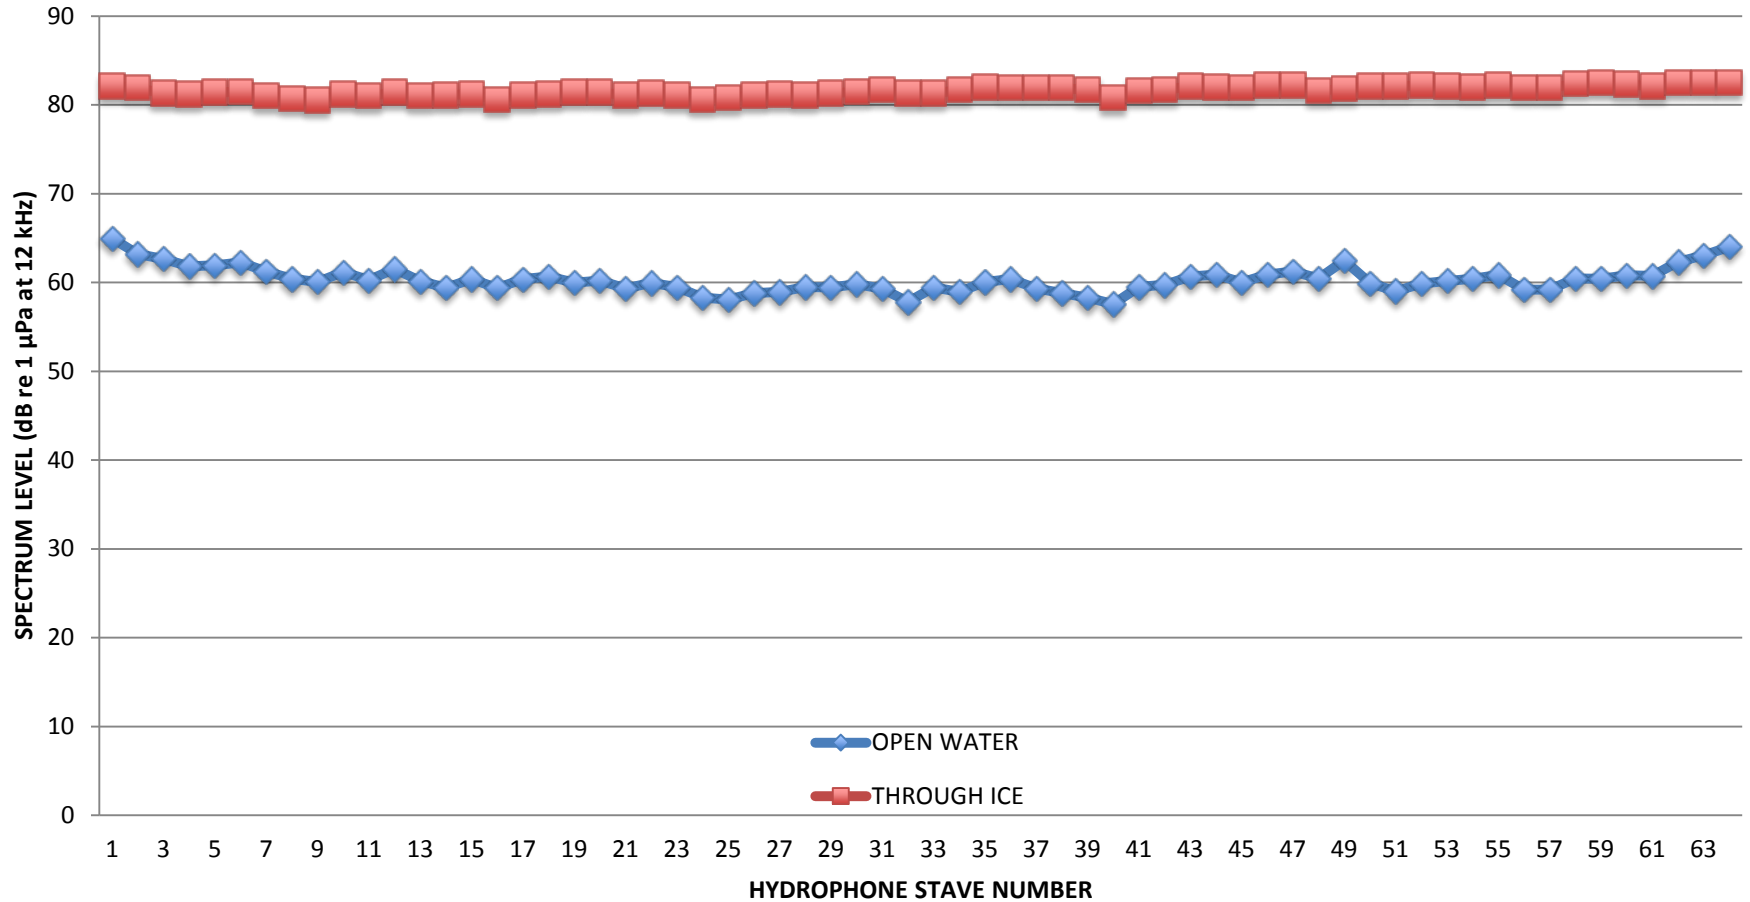
**USCGC HEALY (WAGB-20)
EM 122 RX NOISE LEVEL
80 RPM - OPEN WATER VS THROUGH THIN ICE
17 AUGUST 2014**
